Contract #: 04-0120F4Cty: SF/ALA Rte: 80 PM: 13.2/13.9File #: 1.28**WELDING INSPECTION REPORT****Resident Engineer:** Casey, William**Address:** 333 Burma Road**City:** Oakland, CA 94607**Report No:** WIR-029394**Date Inspected:** 23-Mar-2013**Project Name:** SAS Superstructure**OSM Arrival Time:** 700**Prime Contractor:** American Bridge/Fluor Enterprises, a JV**OSM Departure Time:** 1530**Contractor:** American Bridge/Fluor Enterprises, a JV**Location:** Job Site

CWI Name:	Bonifacio Daquinag and Bernie Docena			CWI Present:	Yes	No
Inspected CWI report:	Yes	No	N/A	Rod Oven in Use:	Yes	No N/A
Electrode to specification:	Yes	No	N/A	Weld Procedures Followed:	Yes	No N/A
Qualified Welders:	Yes	No	N/A	Verified Joint Fit-up:	Yes	No N/A
Approved Drawings:	Yes	No	N/A	Approved WPS:	Yes	No N/A
				Delayed / Cancelled:	Yes	No N/A
Bridge No:	34-0006			Component:	SAS OBG

Caltrans Office of Structural Material (OSM) Quality Assurance Inspector (QAI) Joselito Lizardo was present at the Self Anchored Suspension (SAS) job site as requested to perform observations on the welding of components for the San Francisco Oakland Bay Bridge (SFOBB) Project.

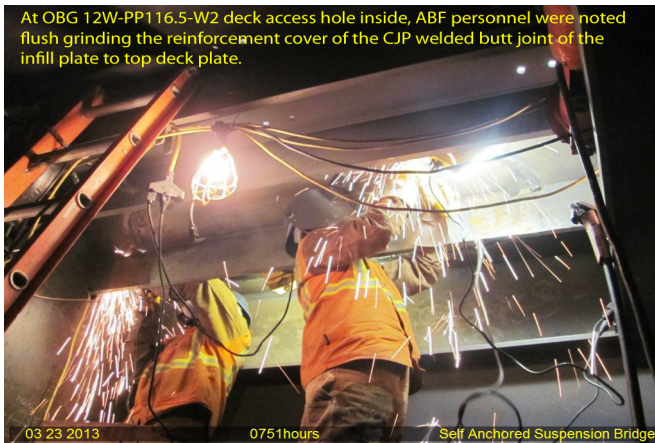
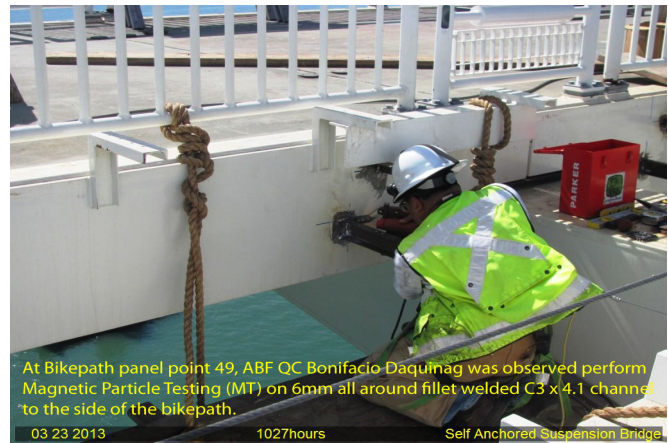
At the request of Quality Control Field Supervisor, Bonifacio Daquinag, QA has randomly verified the QC MT on temporary welded lifting lug removal mentioned below. The QA verification was performed to verify that the VT/MT inspection performed by the QC inspector meet the requirements of the contract documents. At the conclusion of the QA verification it appeared that the ground removal of the lifting lugs and the QC inspection complied with the contract documents.

1. L14W-PP124.65-W3 South – OBG lifting lug (pyramid) removal QA verified
2. L13W-PP122.65-W3 South – OBG lifting lug (pyramid) removal QA verified
3. L13W-PP121.65-W3 South – OBG lifting lug (pyramid) removal QA verified

At OBG 12W-PP116.5-W2 deck access hole outside, QA randomly observed ABF/JV qualified welder Lin E. Yun continuing to perform back welding fill pass on the Complete Joint Penetration (CJP) butt joint. The welder was observed manually welding in the 4G (overhead) position utilizing a Shielded Metal Arc Welding (SMAW) with 5/32" diameter E7018H4R electrode and implementing Caltrans approved Welding Procedure Specification (WPS) ABF-WPS-D15-1040C. The joint being welded has a single V-groove butt joint welded with steel backing bar. ABF Quality Control (QC) Bernie Docena was noted monitoring the welding parameters of the welder. QA randomly monitored the welding parameter with reading of 130 amperes which appears in conformance to the contract requirements. During the shift, SMAW fill pass welding was completed and the welder together with an apprentice ABF personnel performed flush grinding into the cover of the just back welded CJP butt joint plate.

At Bikepath panel point PP49, this QA randomly observed ABF welder Jose Torres perform all position fillet welding all around 2" x 2" x .25" angular and C channel C3 x 4.1 PS-3 pipe support. The welder was noted fillet welding the pipe support per ZPMC drawing BK-MEP-16 as replacement for the damaged same supports at panel points PP49 and PP89. During welding, the welder was noted using Shielded Metal Arc Welding (SMAW) with 1/8" diameter E7018H4R electrode implementing Caltrans approved Welding Procedure Specification (WPS) ABF-WPS-D15-F1200A. ABF QC Bonifacio Daquinag was noted monitoring the welders' welding parameter and workmanship of the fillet welding. Since this was a replacement for the damaged pipe support, this QA had
